Twin Lakes Wetland Report
5/13/22
Gay Austin

The Colorado Native Plant Society is deeply committed to preserving fens and wetlands in Colorado. In Colorado, wetlands encompass 1.5% of the total land mass, and fens just 0.3% of mountain wetlands (Chimner and Cooper 2003). It has come to our attention that wetlands and potentially a fen are being hydrologically modified and dewatered just north of Twin Lakes in the area of Bartlett Gulch. This is potentially a Clean Water Act violation.

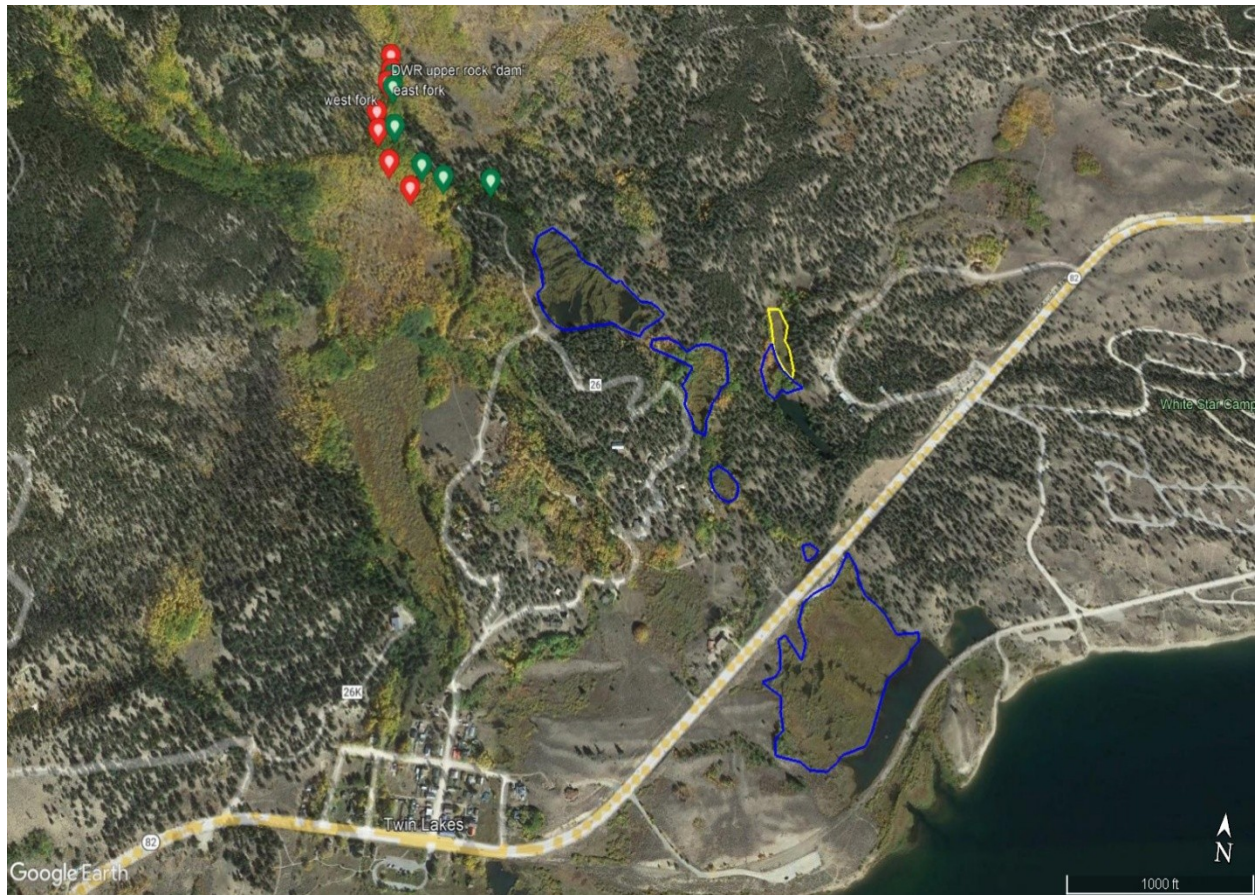
Overview map showing the town of Twin Lakes (bottom left), Twin Lakes (bottom right), a portion of Bartlett Gulch (red and green dots), the wetlands supported by the east fork of Bartlett Gulch (blue lines), and a fen (yellow).

At the bottom of this report is the attached National Wetland Inventory (NWI 1979) map showing red arrows pointing to the wetlands that are normally supported by perennial water flow in the east fork of Bartlett Gulch. The Mount Elbert topographic quadrangle map (2013) clearly shows a perennial stream along the east fork. Field surveys by Gay Austin verified that this water has been diverted to the west fork of Bartlett Gulch by the state Division of Water Resources (see field survey map below). Green dots represent points with photos along the dewatered east fork. Blue lines show the wetlands along this stretch. Red dots show the west fork where all of the Bartlett Gulch water is currently flowing. A fen is outlined in yellow. Since the DWR dams were put in place, beavers have moved down into the fen where there is still groundwater flow. Acres of wetlands in the east fork area have been supporting beavers, migratory birds, elk, deer, bears, other wildlife species, and wetland plants for decades. Although there are multiple channels in Bartlett Gulch due to past landslides and large spring runoffs, the east channel has more evidence of sustained perennial flows. There are large wetlands with wetland plant communities such as beaked sedge (*Carex utriculata*), more willow growth than the west fork, beaver dams and ponds with current beaver activity. Beavers generally build dams along streams with perennial flows, not ephemeral or intermittent drainages.

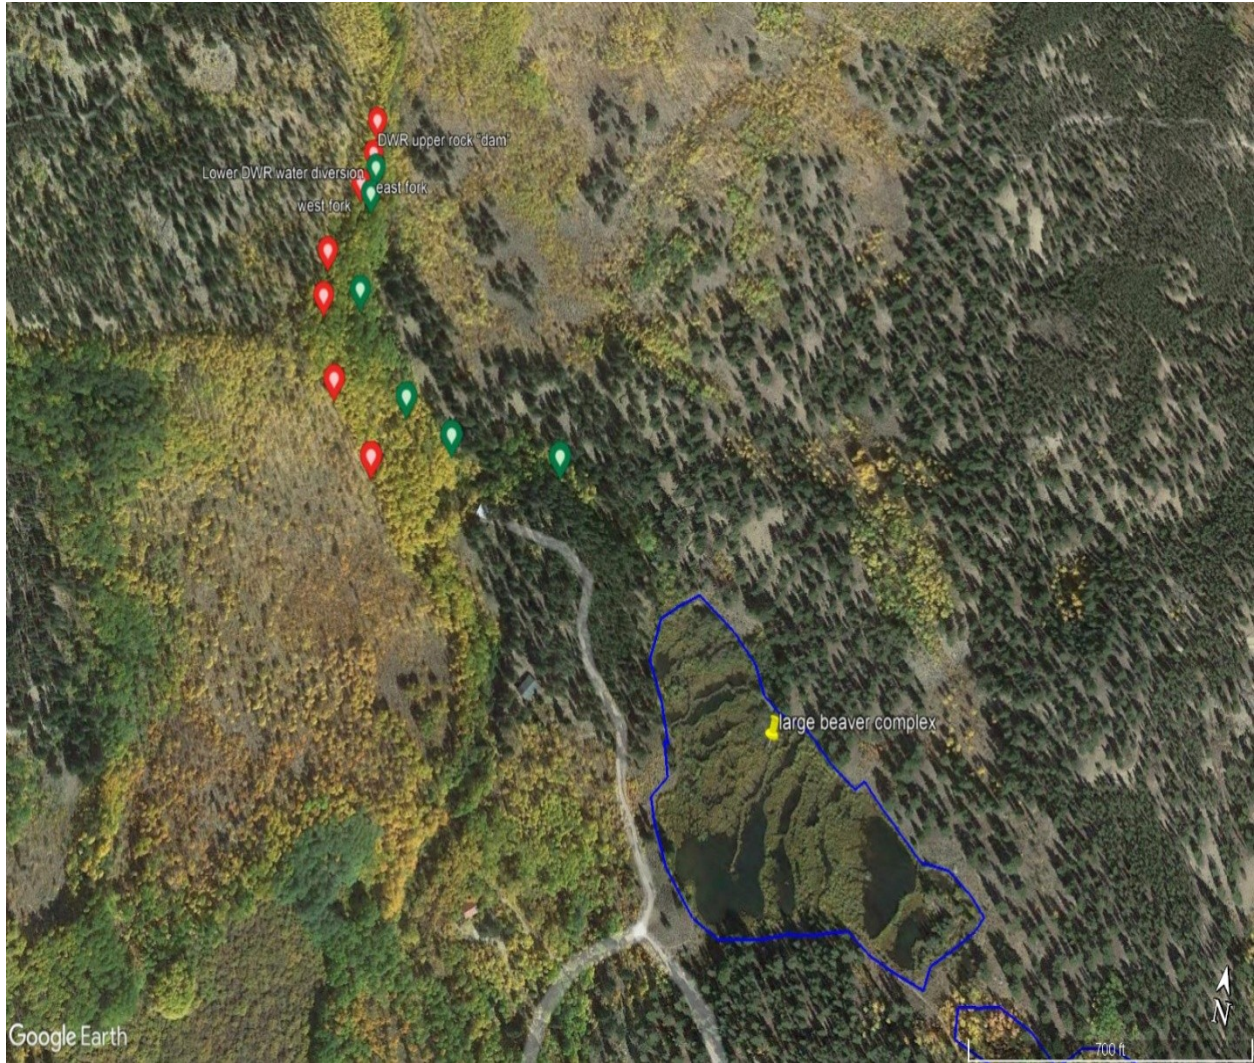
Closeup of middle section of Bartlett Gulch showing field survey points on the west fork (red dots), east fork (green dots), and a large beaver complex supported by perennial water flow from the east fork.

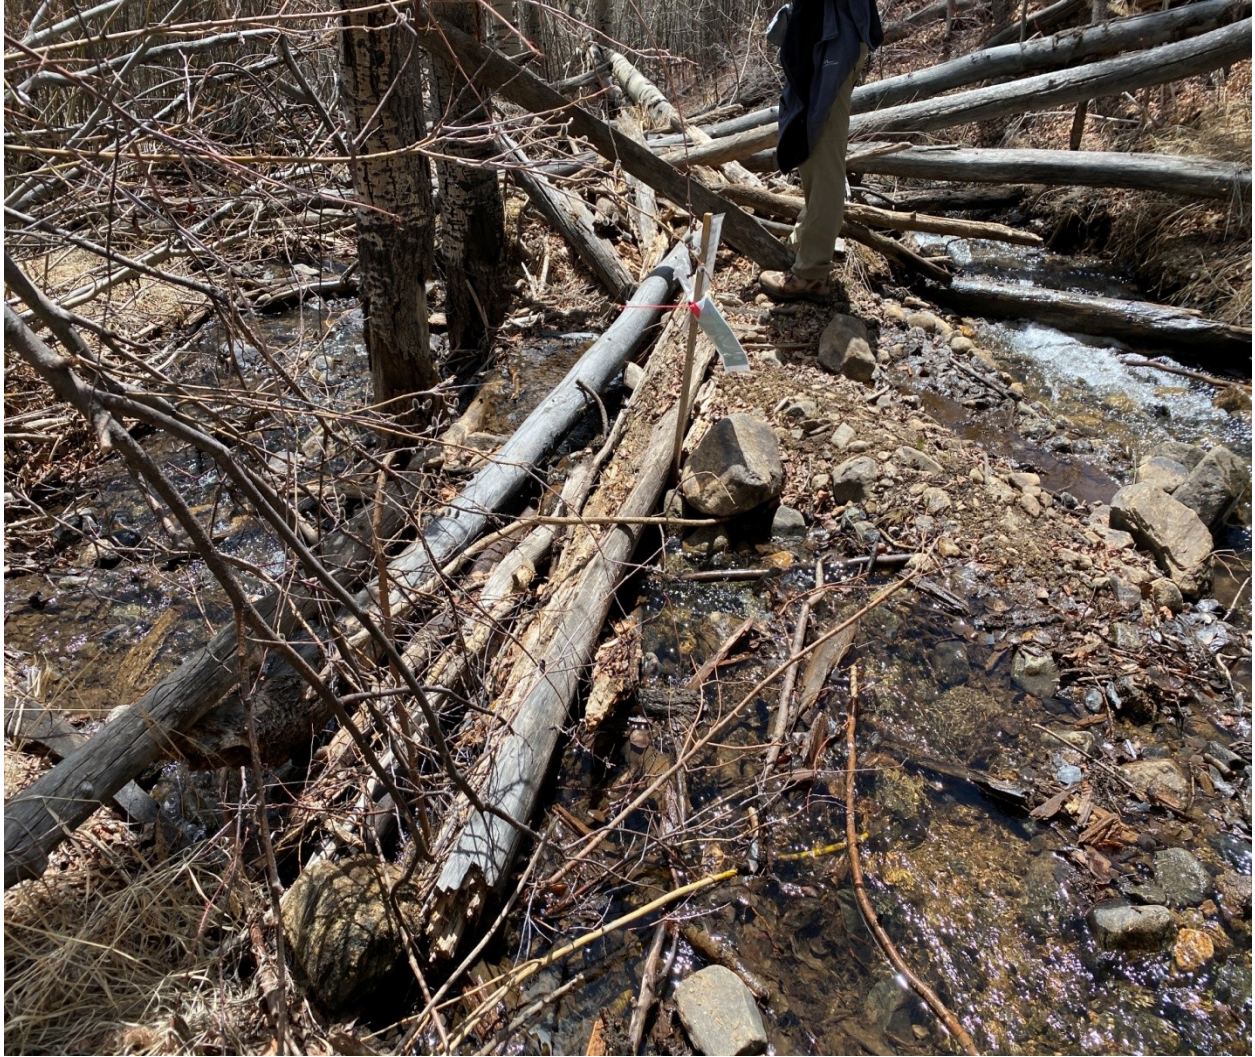
Looking south with east fork on left and west fork on right. Upper DWR partial diversion of Bartlett Gulch showing use of old beaver dam to partially move the flow of Bartlett Gulch to the west fork.

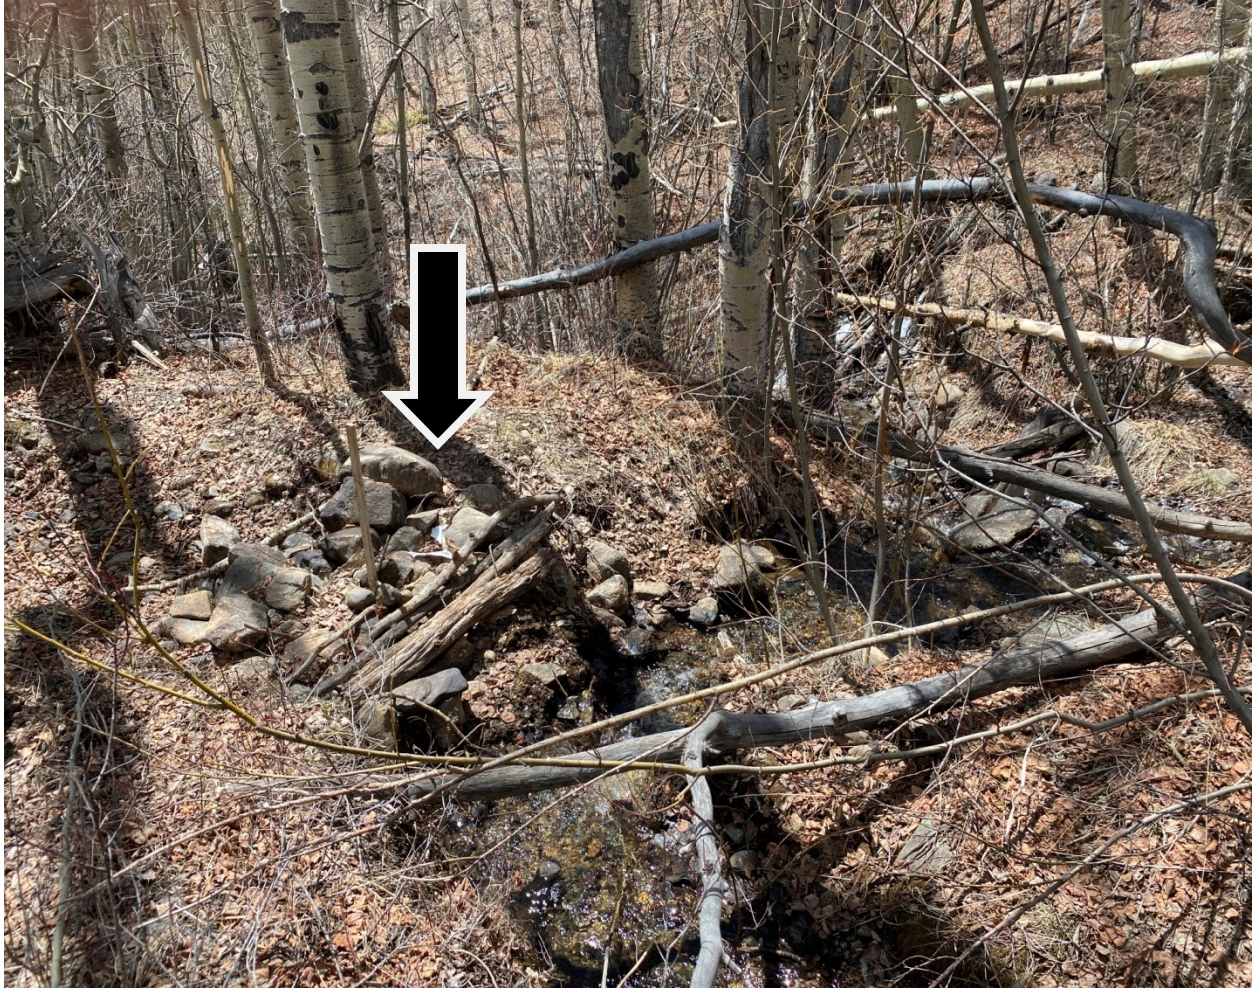
Looking south just below 1st dam at DWR 2nd dam (black arrow), plugging the east fork on the left. West fork is on the right where all the water from Bartlett Gulch is now flowing.

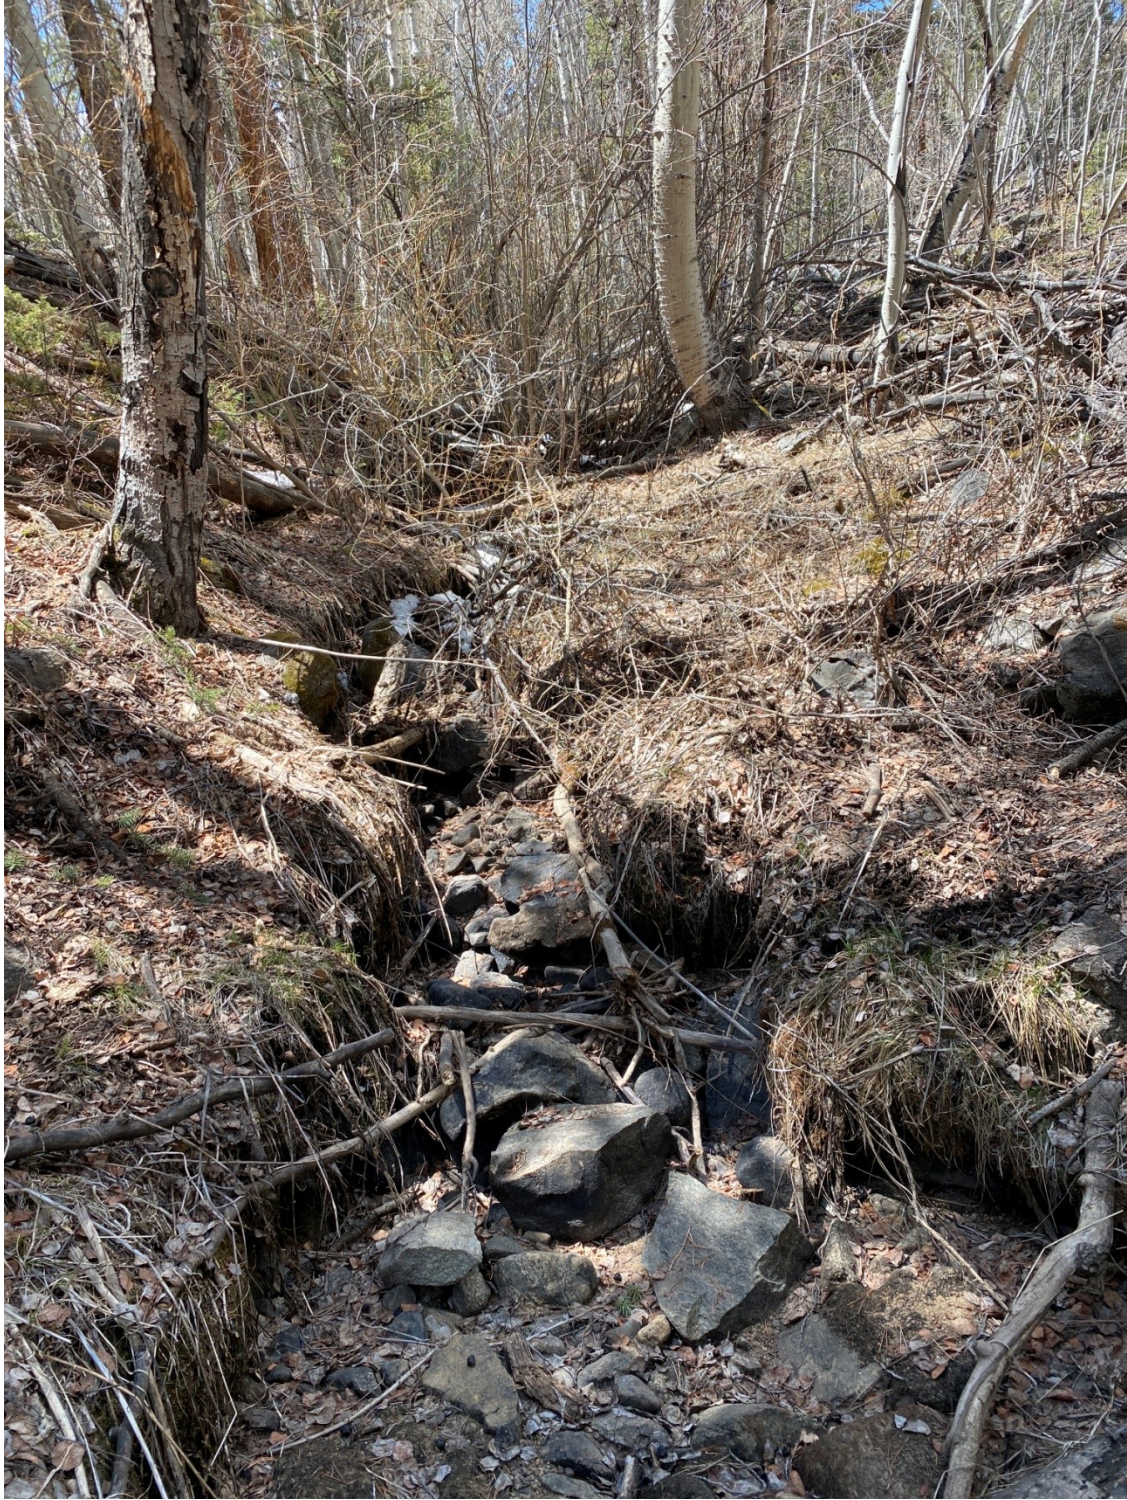
East fork of Bartlett Gulch showing dewatered channel.

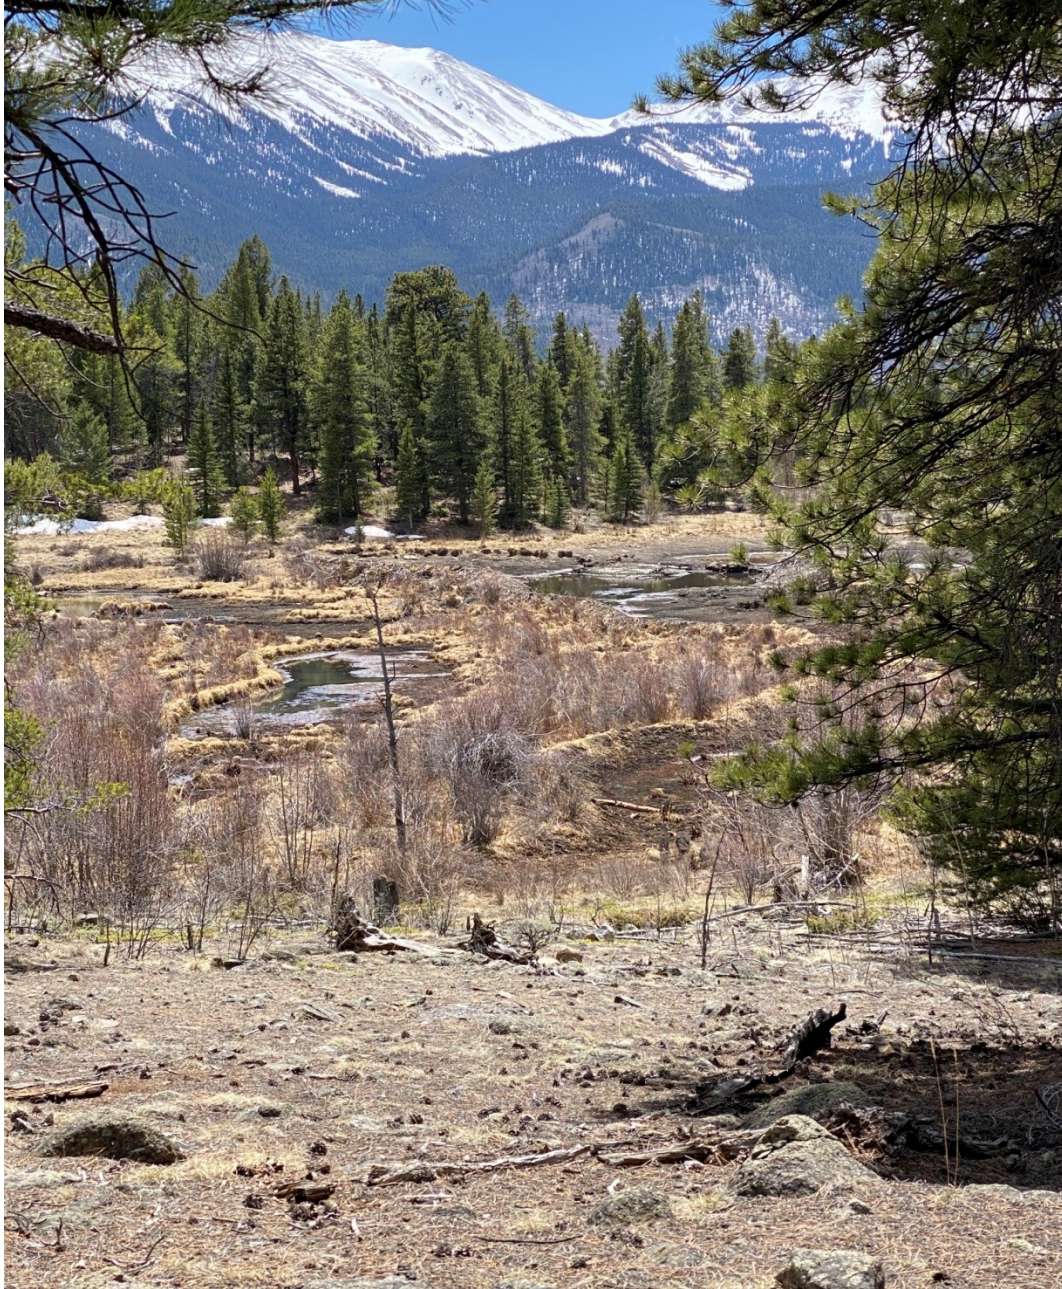
Looking south at large beaver complex just below dewatered east fork of Bartlett Gulch.

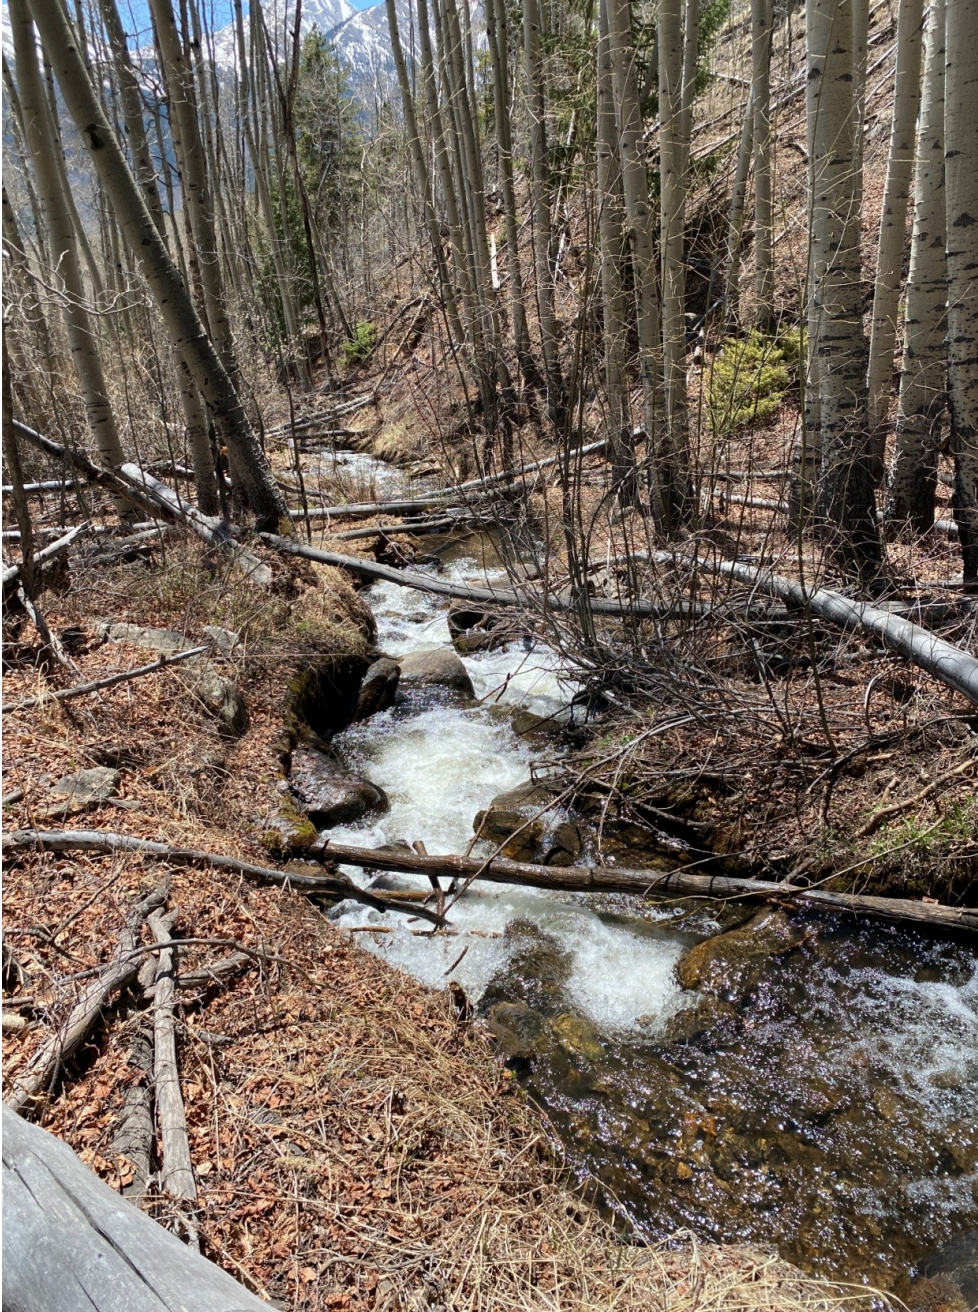
West fork of Bartlett Gulch showing water flow.
